THE SHERMAN TANK in US and Allied Service

Text and colour plates by
Steven J. Zaloga

VANGUARD SERIES

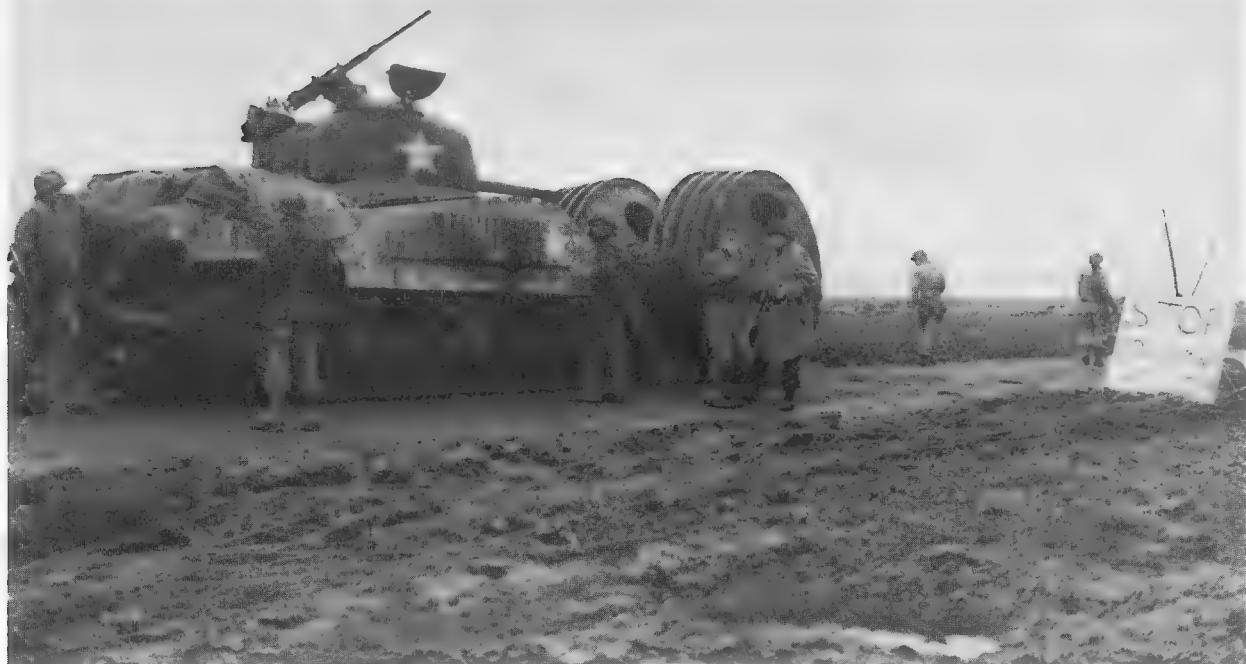
Mines are always a constant threat to tanks, and this danger led to bizarre counter-measures. Here a T1E3 of the 738th Tank Bn. (Special) prepares to clear a stretch of road near Beggendorf, Germany, on 11 December 1944. About 200 of these 'Aunt Jemima' mine-rollers were built; while effective on roads, they were less popular with the troops than the flail-type mine detonators as they easily bogged down on soft terrain.

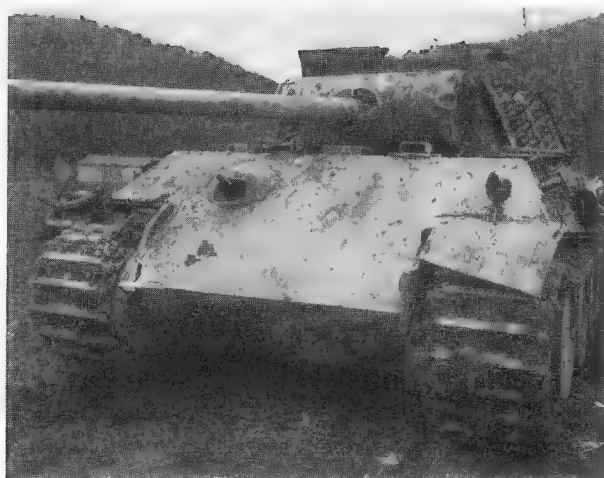
A close-up look at a PzKpfw V Ausf. G Panther hit by eight rounds of 76mm APC near Saverne, France. The gouges of six of these rounds are evident, only the hit on the lower left corner of the glacis plate causing a minor penetration. The 76mm gun could only get penetrations against the front of the Panther by using the scarce HVAP ammunition, or by firing from a dangerously close range.

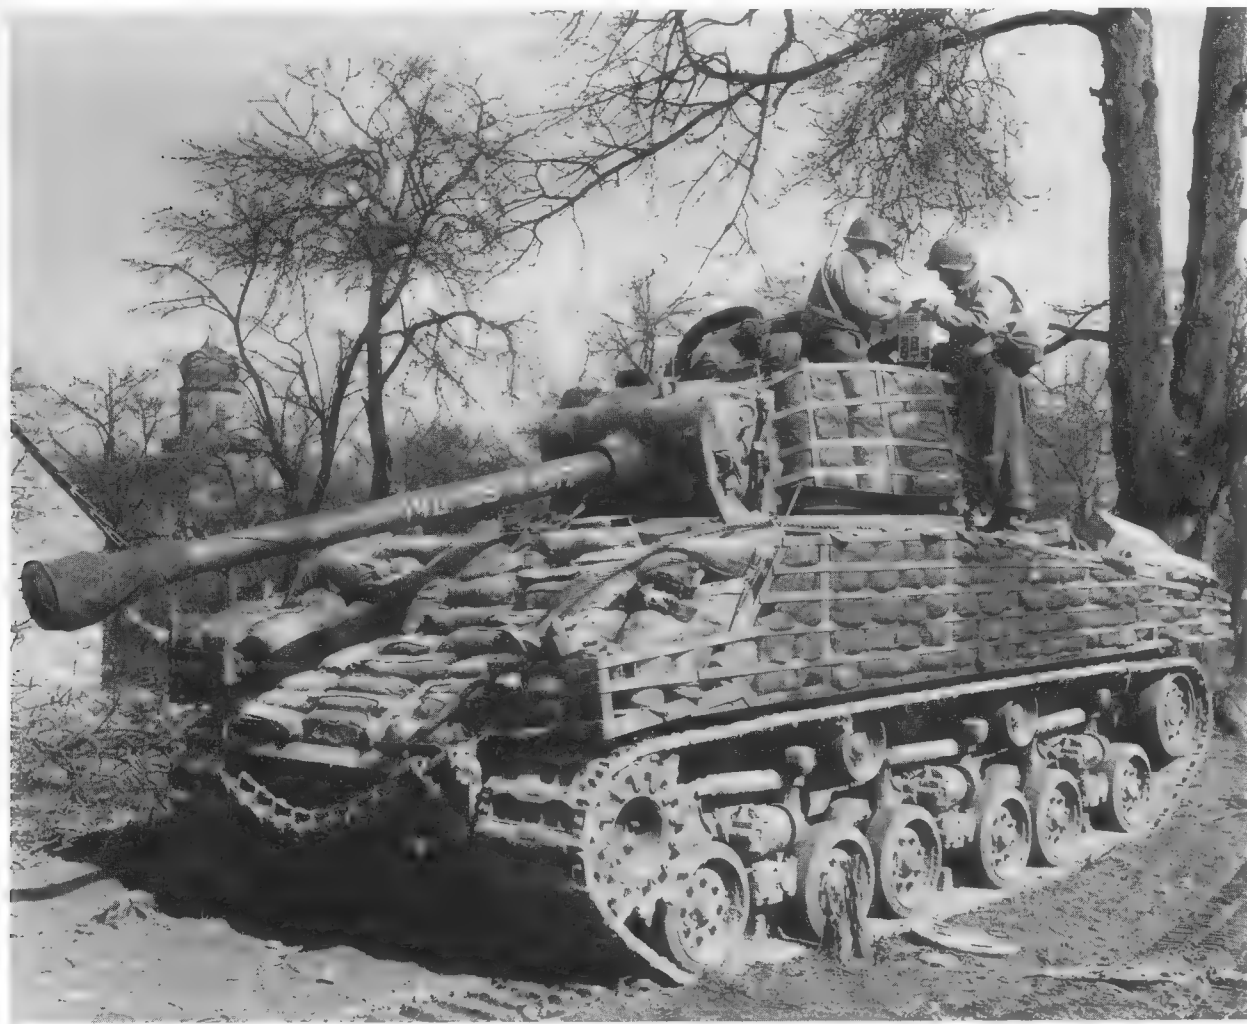
A new M4A3E8 of the 25th Tank Bn., 14th Armd. Div. provides a clear view of the extent of sandbag armour additions. Indeed, the improvised armour covers so much of the hull front that the 14th Armd. Div. frequently painted the 'bumper' unit identification codes on the gun tube. The M4A3E8 was the culmination of Sherman tank development in the Second World War.

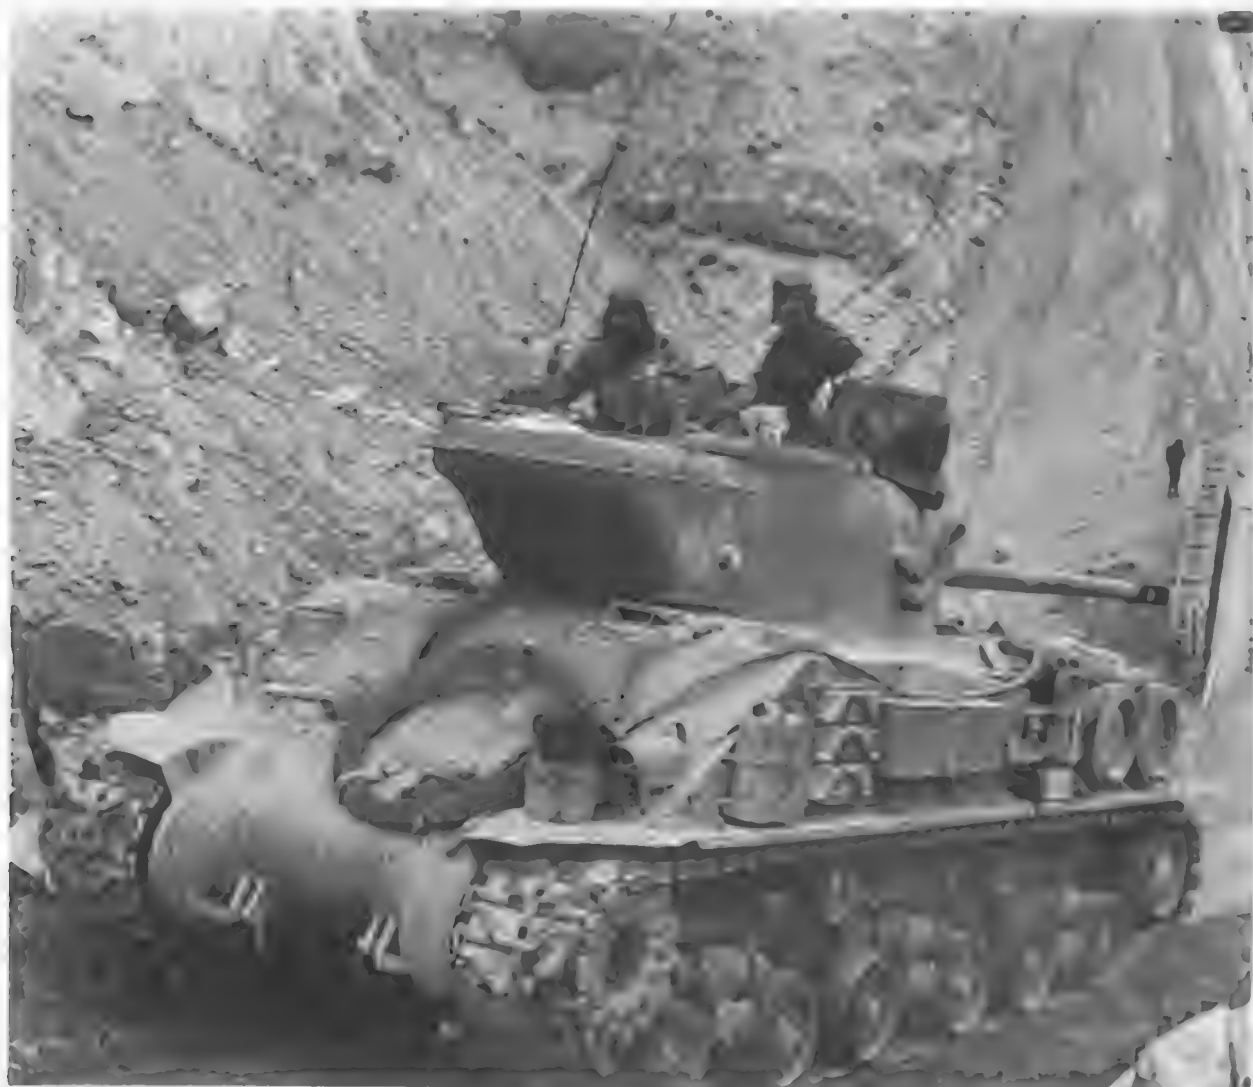
To extend the useful service life of the old Shermans the Israelis rebuilt many of them with new Cummins diesel engines, HVSS suspensions and new French 75mm high-velocity tank guns. This M50 Super Sherman operating on the Golan Heights in 1970 is armed with the French SA50 gun, which was derived from the 75mm gun in the Sherman's old adversary, the Panther. This view with the turret traversed to the rear clearly shows the large rear turret counter-weight extension needed to house this larger gun. (IDF)
